# Home Inspection Report

**1234 Main St., Anywhere, Ohio 12345**

Friday, January 6, 2017

191286

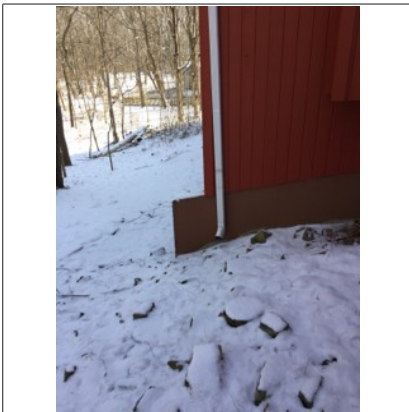
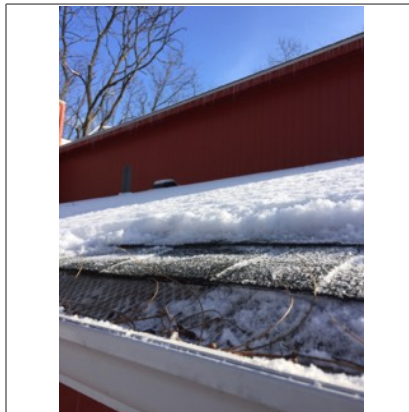
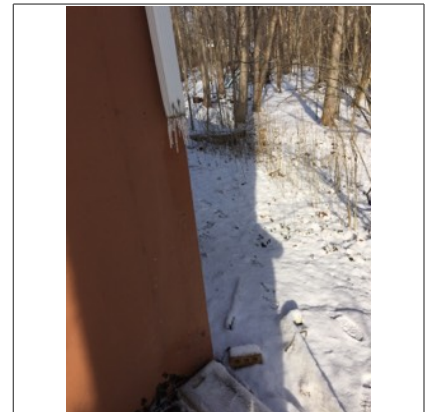
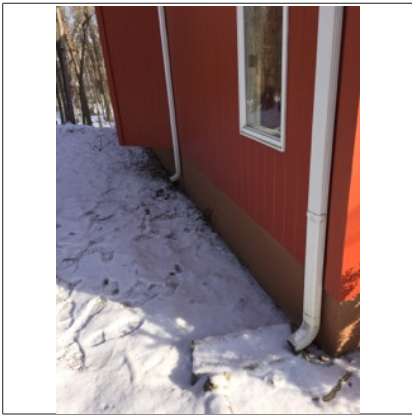
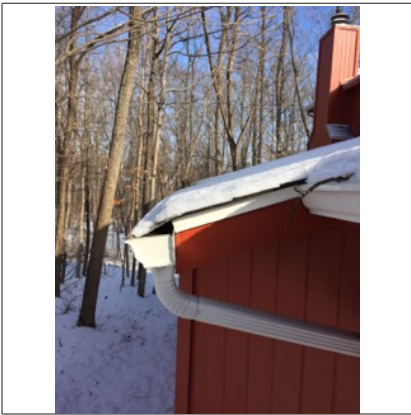
☐ None  
**Condition** ☒ Satisfactory ☐ Marginal ☐ Poor ☐ Rusting ☐ Downspouts needed ☐ Recommend repair/replace  
☒ Needs to be cleaned  
**Material** ☐ Copper ☐ Vinyl/Plastic ☒ Galvanized/Aluminum Other: .  
**Leaking** ☐ Corners ☐ Joints ☐ Hole in main run ☒ No apparent leaks  
**Attachment** ☐ Loose ☐ Missing spikes ☐ Improperly sloped ☒ Satisfactory  
**Extension needed** ☒ North ☒ South ☐ East ☒ West ☐ N/A  
**Comments** Recommend adding downspout extensions to discharge away from the house. 5-6' extensions recommended. One downspout is off recommend reattach.

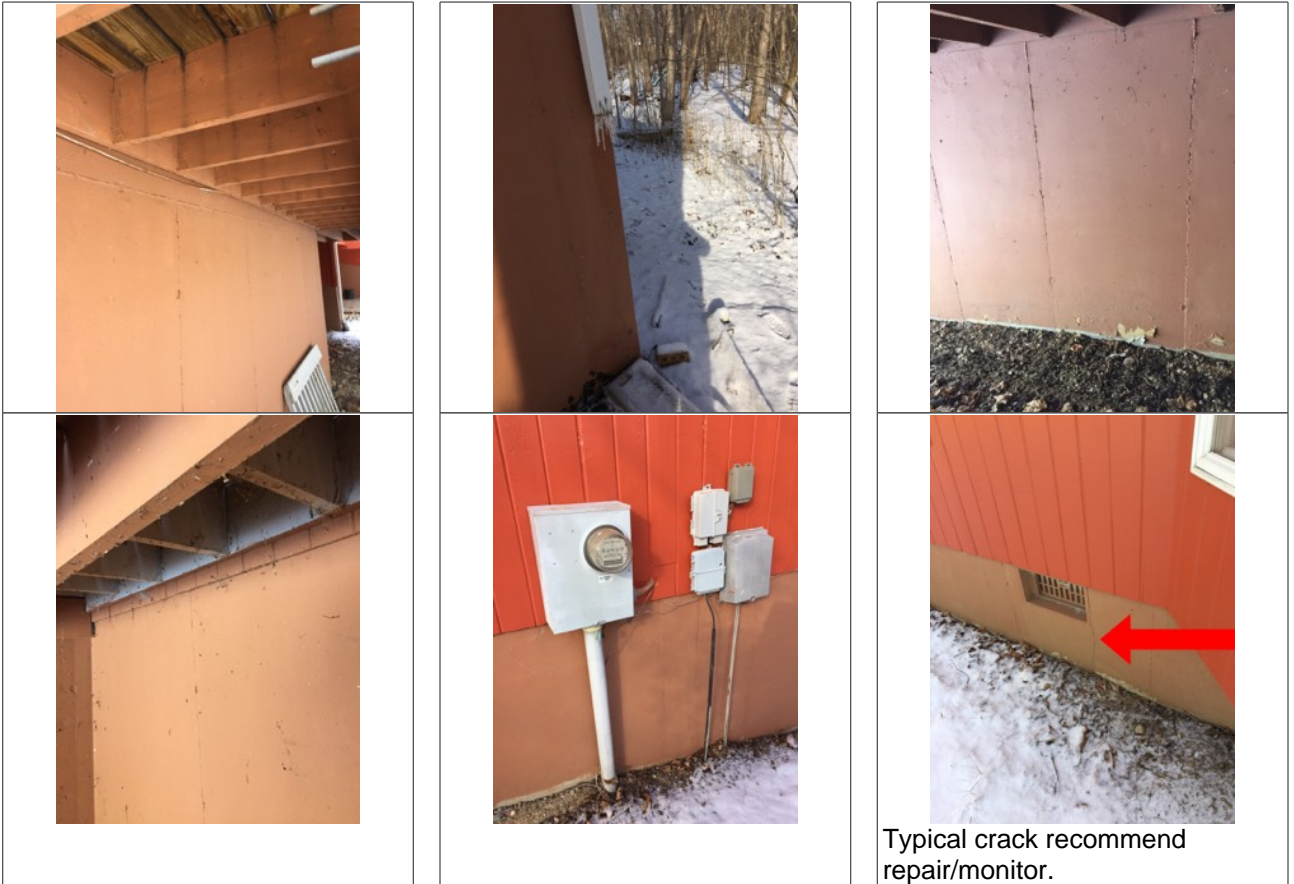
**Foundation Wall** ☐ Concrete block ☒ Poured concrete ☐ Post-Tensioned concrete ☐ Not Visible Other: .  
**Condition** ☒ Satisfactory ☐ Marginal ☐ Monitor ☐ Have Evaluated ☐ Not Evaluated  
**Concrete Slab** ☒ N/A ☐ Not Visible ☐ Satisfactory ☐ Marginal ☐ Monitor ☐ Have Evaluated  
**Comments** Foundation (stem) wall contains typical cracks.

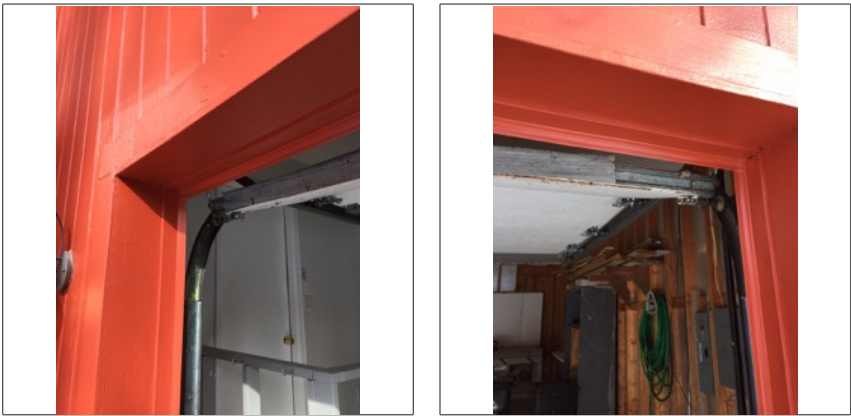
☒ Weatherstripping missing/damaged ☐ Loose/missing

**Comments** Recommend repair/replace weatherstripping.

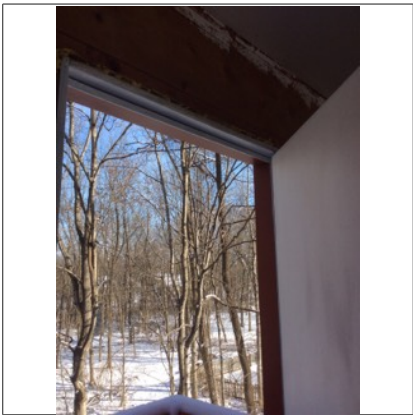
Condition ☐ None ☒ Satisfactory ☐ Marginal ☐ Poor ☐ Damaged/Rusted  
Comments Deadbolt lock doesn't line up with frame recommend repair.

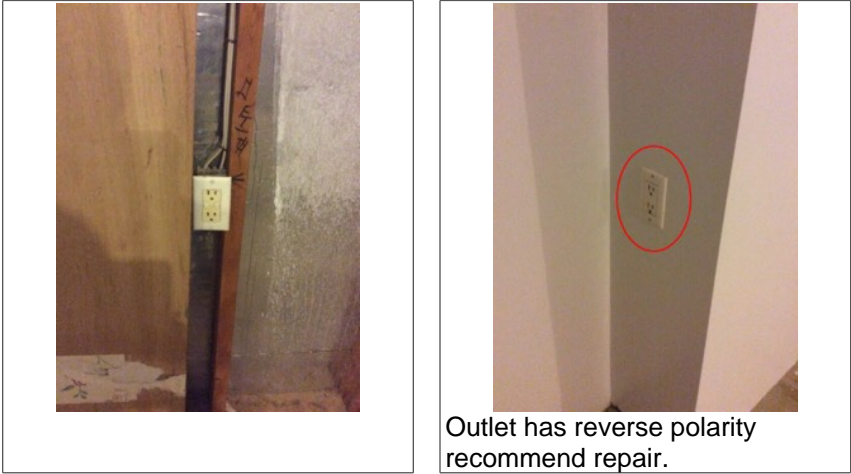
☒ Yes ☐ No ☐ Not Visible Operable: ☒ Yes ☐ No  
Reverse polarity ☒ Yes ☐ No  
Open ground ☐ Yes ☒ No ☐ Safety Hazard  
GFCI Present ☒ Yes ☐ No Operable: ☒ Yes ☐ No ☐ Handyman/extension cord wiring  
☒ Recommend GFCI Receptacles  
Comments GFCI outlet functioning properly.

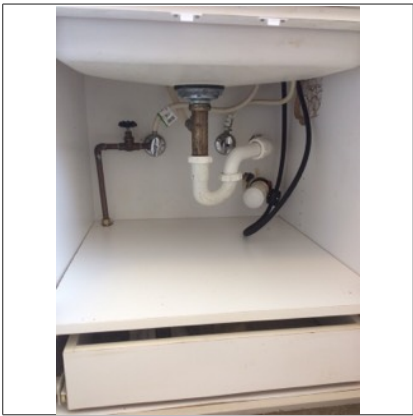
**Comments** Some corrosion where cold water runs into sink recommend dielectric union, recommend monitor for now.

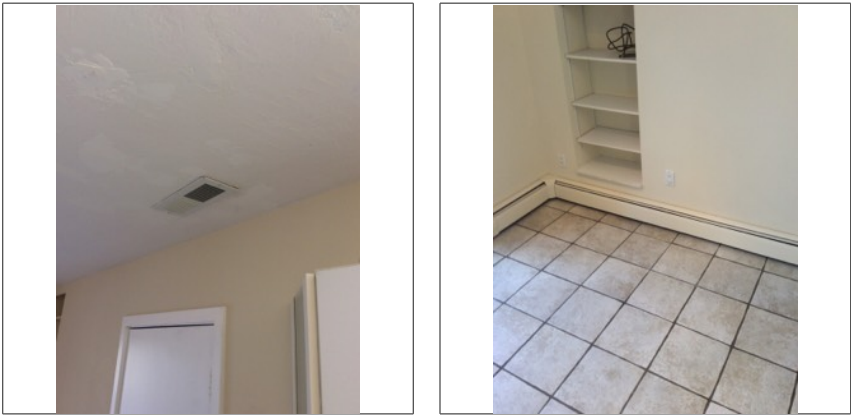
Condition ☒ Satisfactory ☐ Marginal ☐ Poor ☐ Typical cracks ☒ Moisture stains  
Comments Appears to be moisture staining around light fixture recommend monitor.

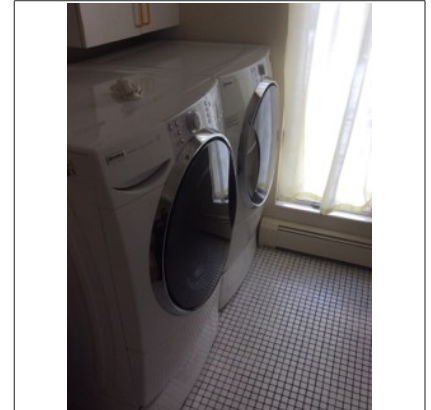
**Comments** Some corrosion at hot/cold water hook ups for washer and under sink due to dissimilar metals, recommend monitor/repair.  
 Open ground within 6 feet of water. Recommend repair

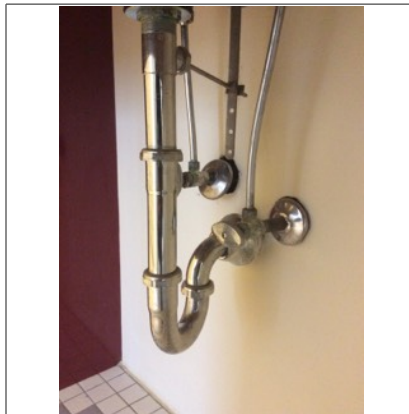
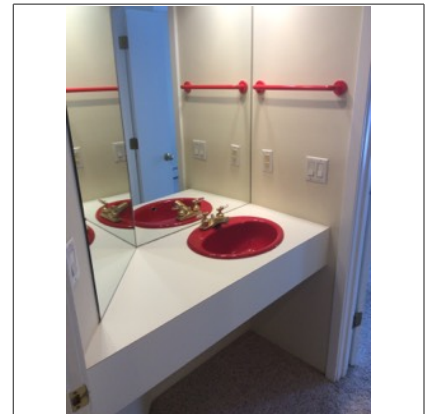
Moisture stains present under sink where carpet is and under the connection to the baseboard heating unit, recommend monitor.

Places where moisture staining present due to dissimilar metals recommend monitor/repair as necessary.

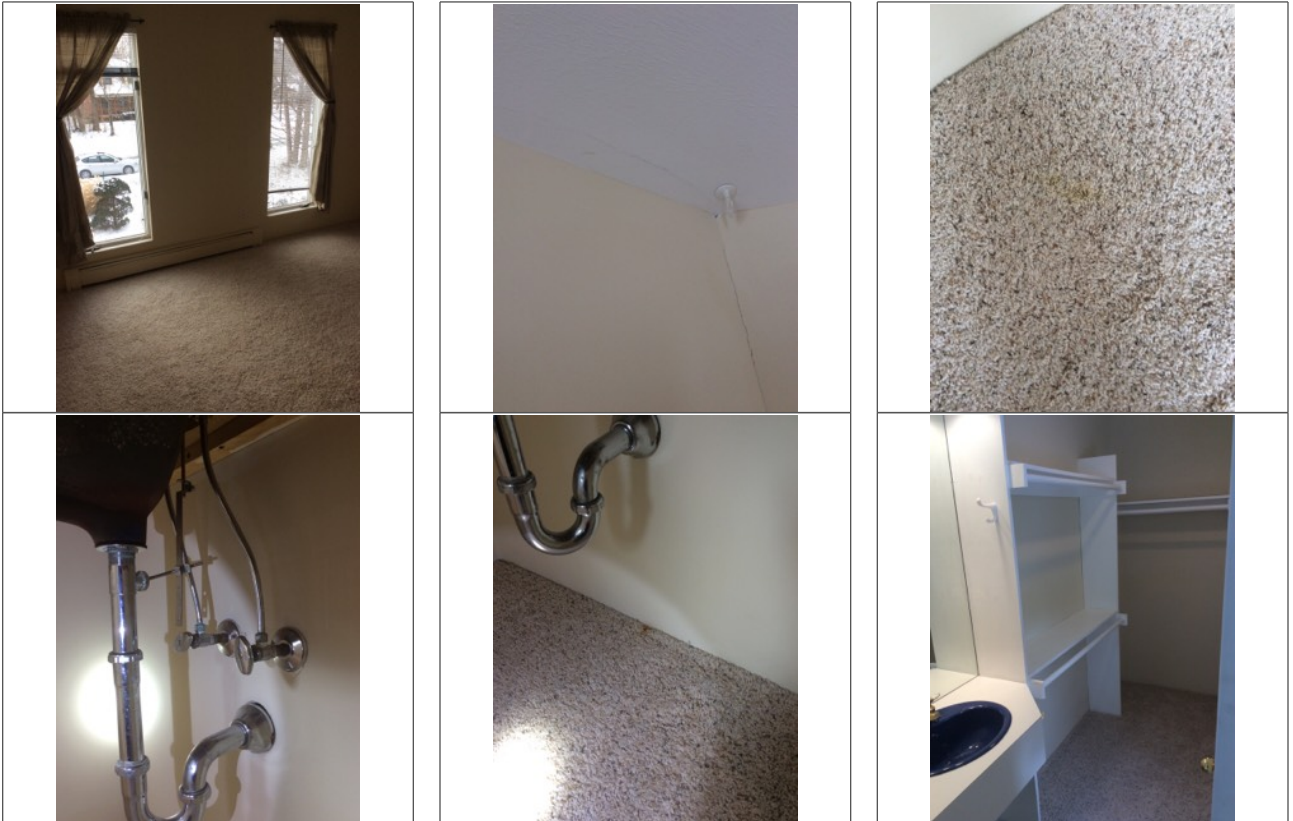
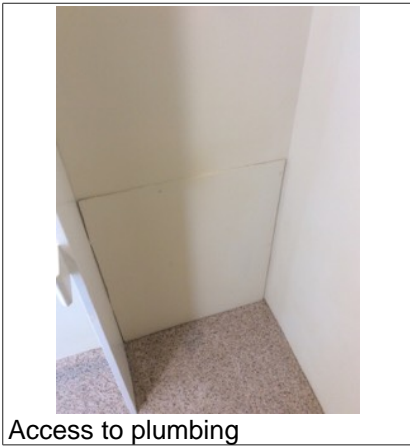
<input type="checkbox"/> Broken/Missing hardware
<b>Comments</b>	Some moisture staining on floor under closet sink, next to outlets under crack in ceiling, and under baseboard heating elements, recommend monitor.
<b>Photos</b>

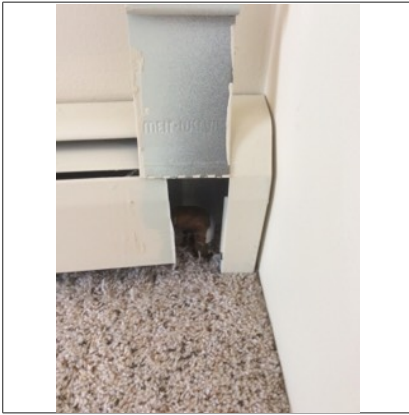
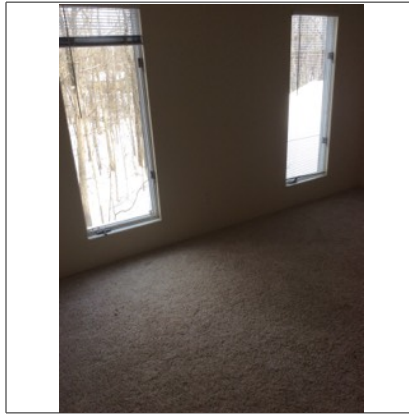
<input checked="" type="checkbox"/> Broken/Missing hardware
<b>Comments</b>	One window won't open due to being caught on upper lock, recommend repair.
<b>Photos</b>

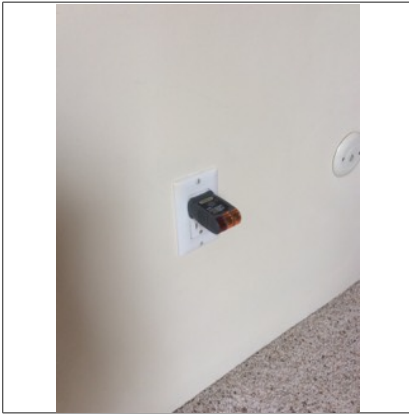
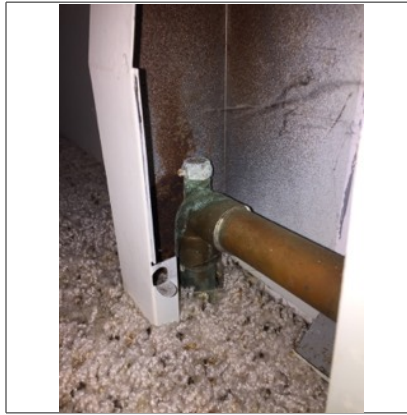
<input type="checkbox"/> Broken/Missing hardware
<b>Comments</b>	Outlet in photo not functioning recommend repair/replace.
<b>Photos</b>

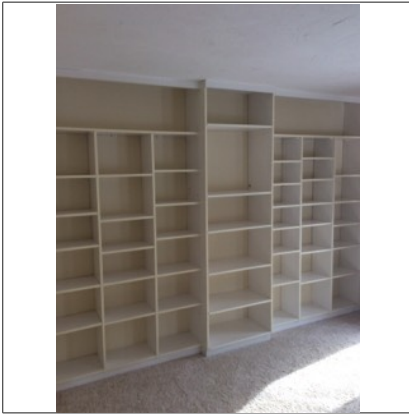
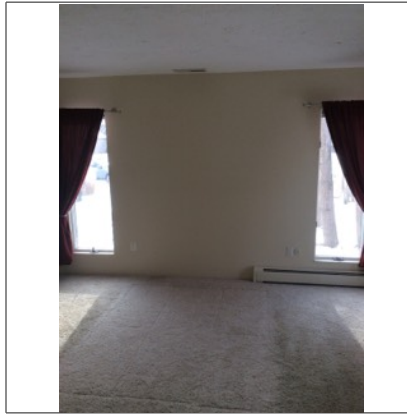
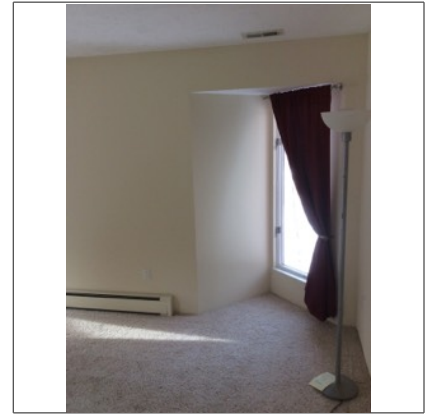
<input type="checkbox"/> Broken/Missing hardware
<b>Comments</b>	Some cosmetic damage to walls recommend paint.
<b>Photos</b>

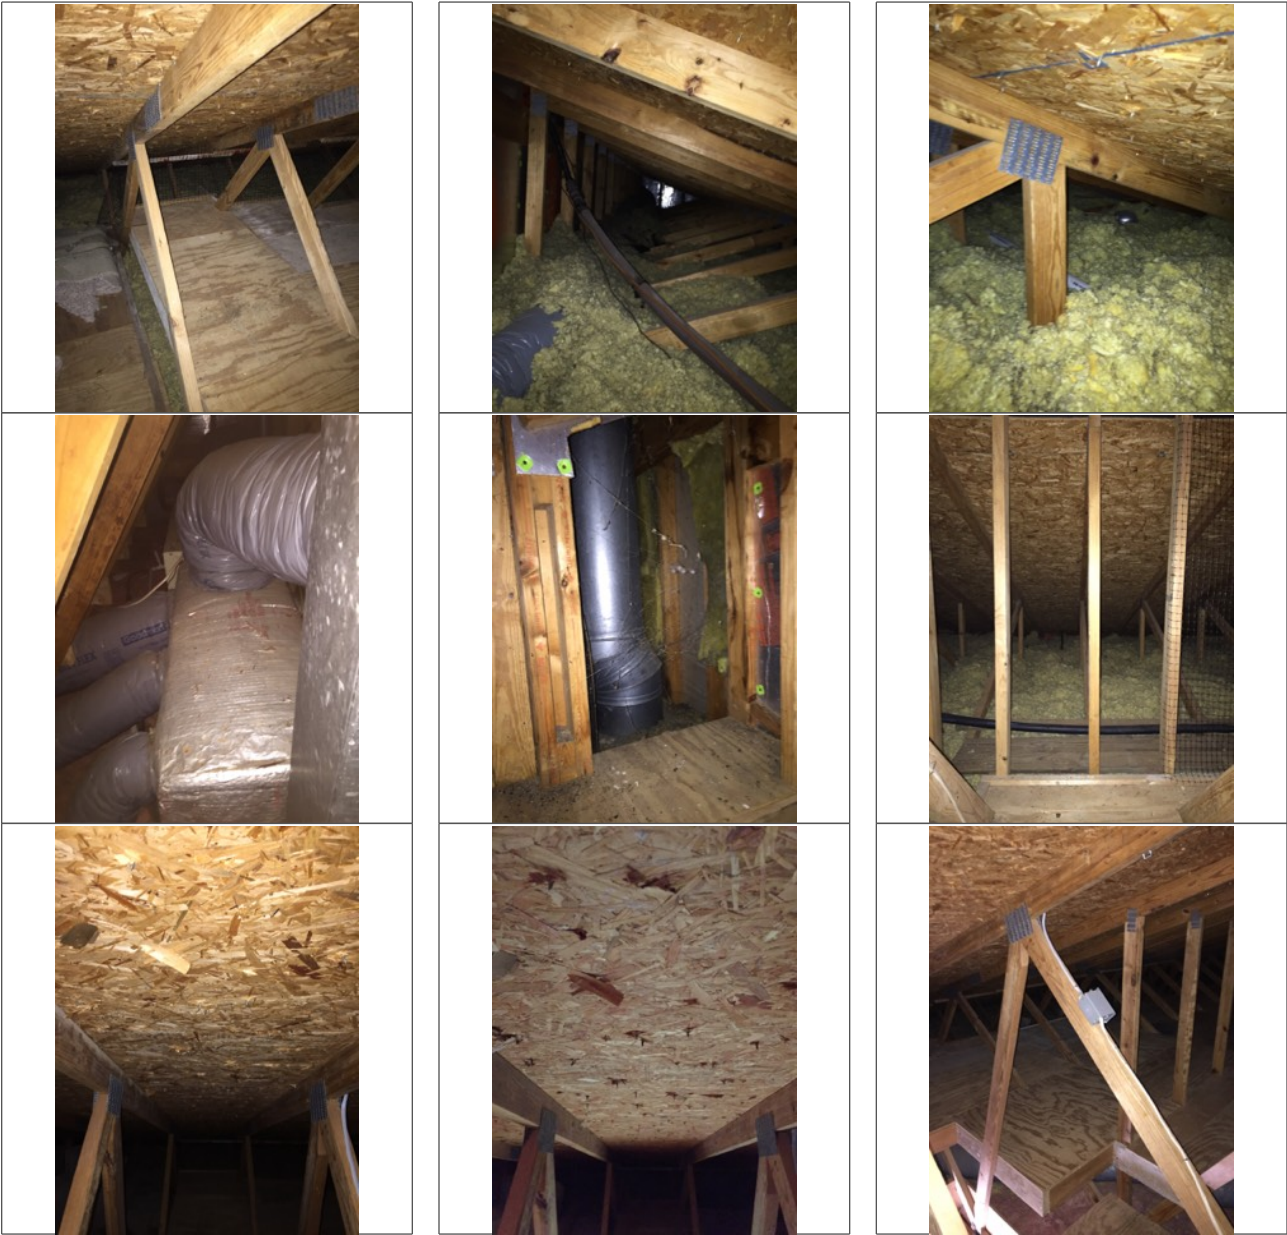
**Comments**  
 Recommend proper weatherstripping be installed around attic access  
 Trusses showed no major defects or damage at the time of inspection.  
 Roof sheathing, examined from the attic, showed no major defects or moisture damage.  
 Insulation was sufficient for homes in this area.  
 Ventilation was normal.  
 Chimney section in attic appeared to be in satisfactory condition.

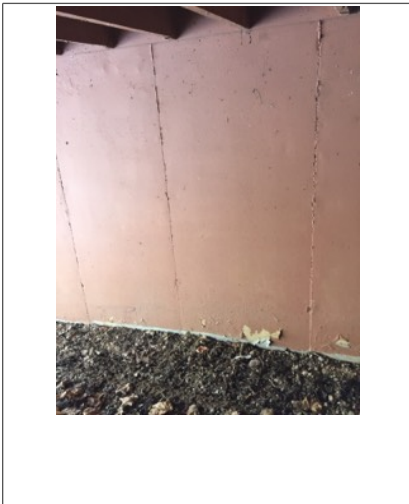
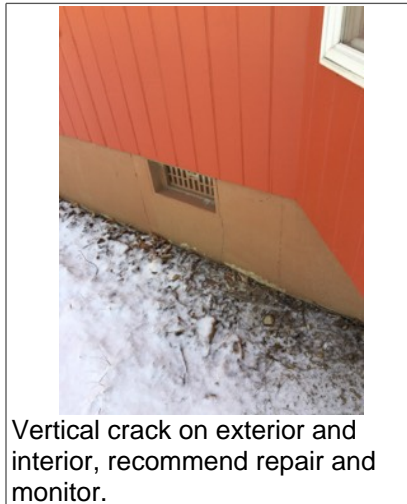
**Comments** Foundation had some cracks, recommend patching and monitoring  
 Foundation appeared to be in overall satisfactory condition.

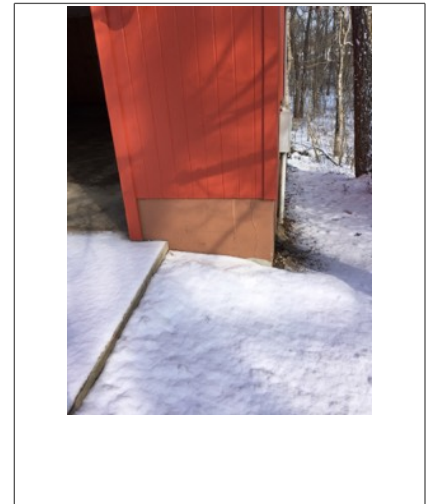
Vertical crack on exterior and interior, recommend repair and monitor.

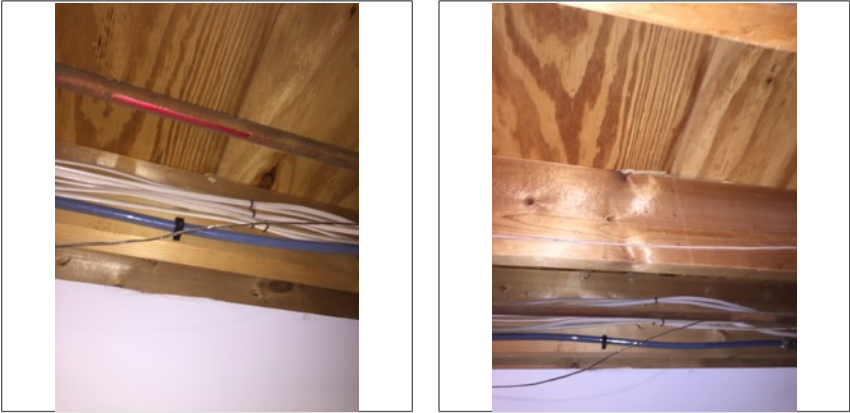
Photos are of area by main entrance that were squeaky. No structural damage observed.

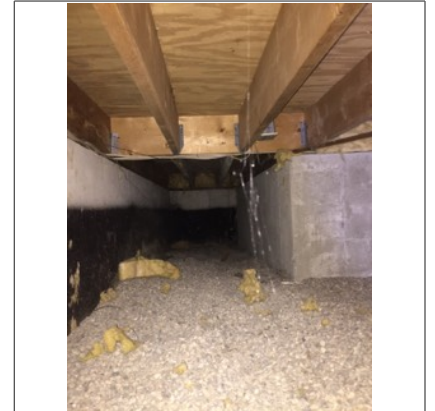
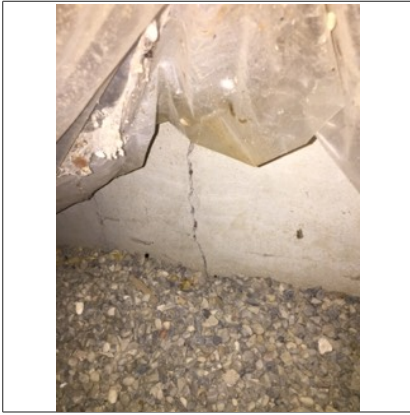
**Condition** ☒ Satisfactory ☐ Marginal ☐ Have Evaluated ☐ Monitor ☒ Cracks ☐ Movement  
**Material** ☐ Concrete block ☒ Poured concrete ☐ Stone ☐ ICF ☐ Wood ☐ Brick  
**Comments** Typical cracks.  
**Photos**

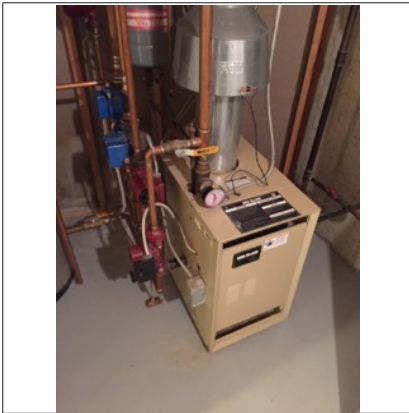
**Comments** Some corrosion on copper pipes no leaks apparent at time of inspection recommend monitor.
