# Home Inspection Report

**1234 Main St., Anywhere, Ohio 12345**

Friday, January 6, 2017

191286

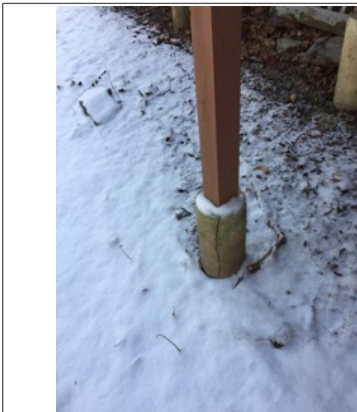
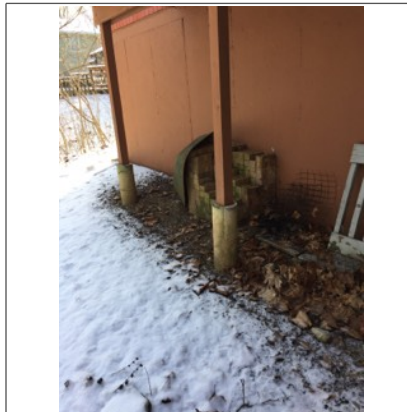
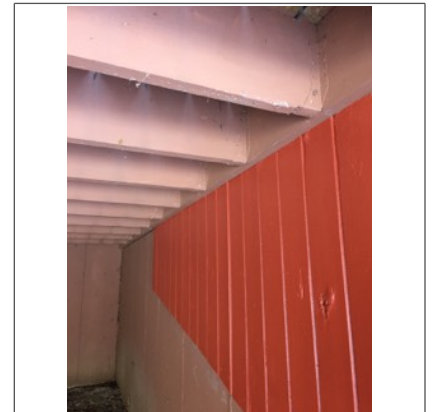
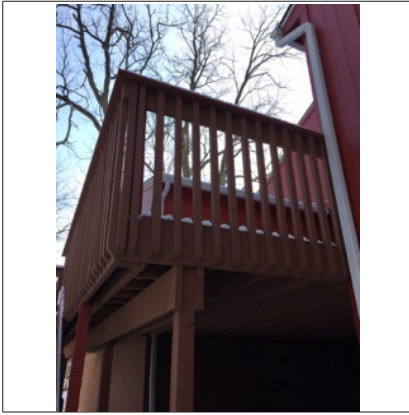
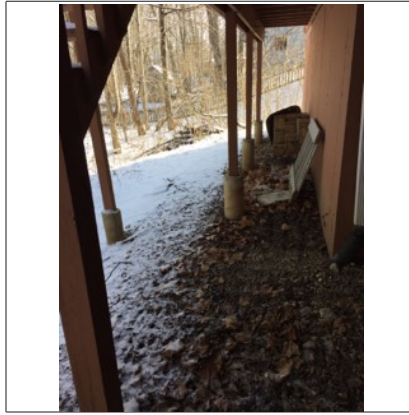
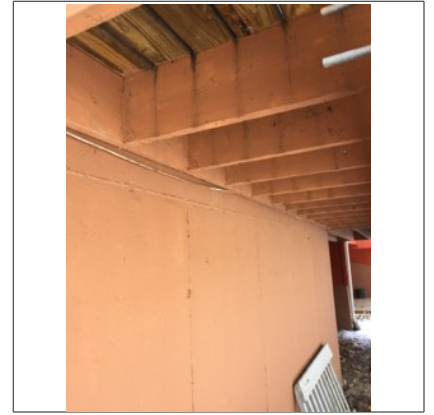
☐ None ☐ Not Visible  
**Material** ☒ Wood ☐ Metal ☐ Composite ☐ Railing/Balusters recommended  
**Condition** ☒ Satisfactory ☐ Marginal ☐ Poor ☐ Wood in contact with soil  
**Finish** ☐ Treated ☒ Painted/Stained Other: . ☐ Safety Hazard ☐ Improper attachment to house  
☐ Railing loose ☐ Not Applicable  
**Comments**  
**Photos**

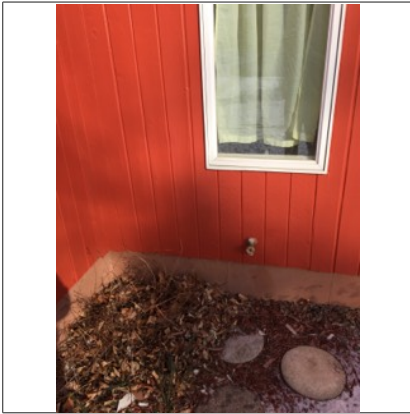
- ☐ N/A
- Condition** ☒ Satisfactory ☐ Marginal ☐ Poor ☐ No anti-siphon valve ☐ Recommend Anti-siphon valve
- Operable** ☐ Yes ☐ No ☒ Not Tested ☐ Not On
- Comments** Not tested due to temperature, no apparent defects at time of inspection.

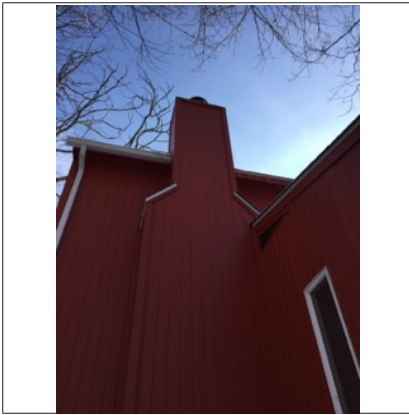
☐ None  
**Location(s)** Northwest  
**Viewed From** ☐ Roof ☒ Ladder at eaves ☒ Ground (Inspection Limited) ☒ With Binoculars  
**Rain Cap/Spark Arrestor** ☒ Yes ☐ No ☐ Recommended  
**Chase** ☐ Brick ☐ Stone ☐ Metal ☐ Blocks ☒ Framed  
**Evidence of** ☐ Holes in metal ☐ Cracked chimney cap ☐ Loose mortar joints ☐ Flaking ☐ Loose brick ☐ Rust  
☒ No apparent defects  
**Flue** ☐ Tile ☐ Metal ☐ Unlined ☒ Not Visible  
**Evidence of** ☐ Scaling ☐ Cracks ☐ Creosote ☒ Not evaluated ☒ Have flue(s) cleaned and re-evaluated  
☐ Recommend Cricket/Saddle/Flashing ☐ No apparent defects  
**Condition** ☒ Satisfactory ☐ Marginal ☐ Poor ☐ Recommend Repair  
**Comments** No apparent defects.  
**Photos**

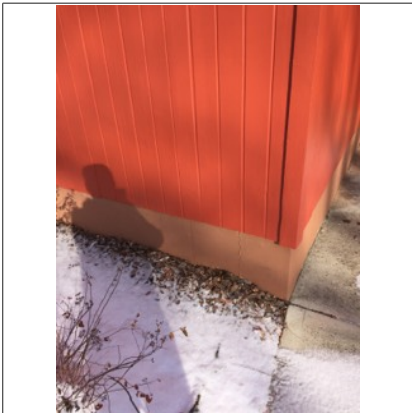
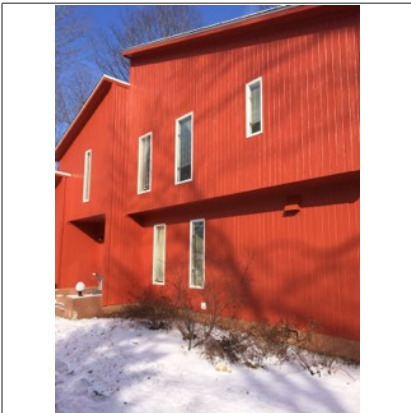
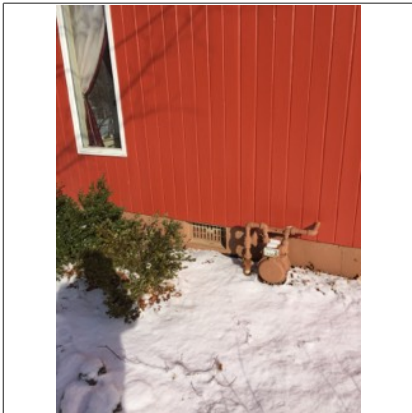
Siding appeared to be all intact and in overall satisfactory condition.

Comments Normal caulking maintenance recommended.

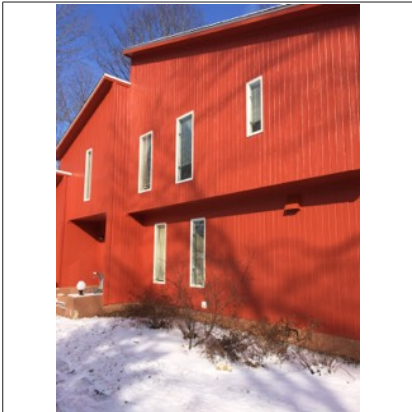
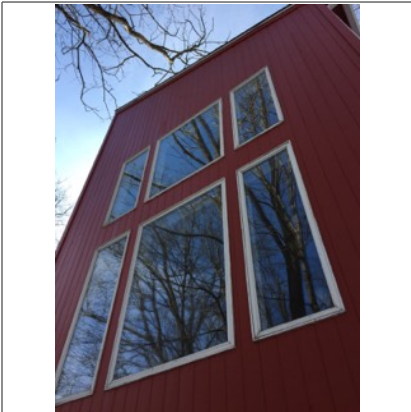
Comments Trim appeared to be intact and in overall maintained condition.

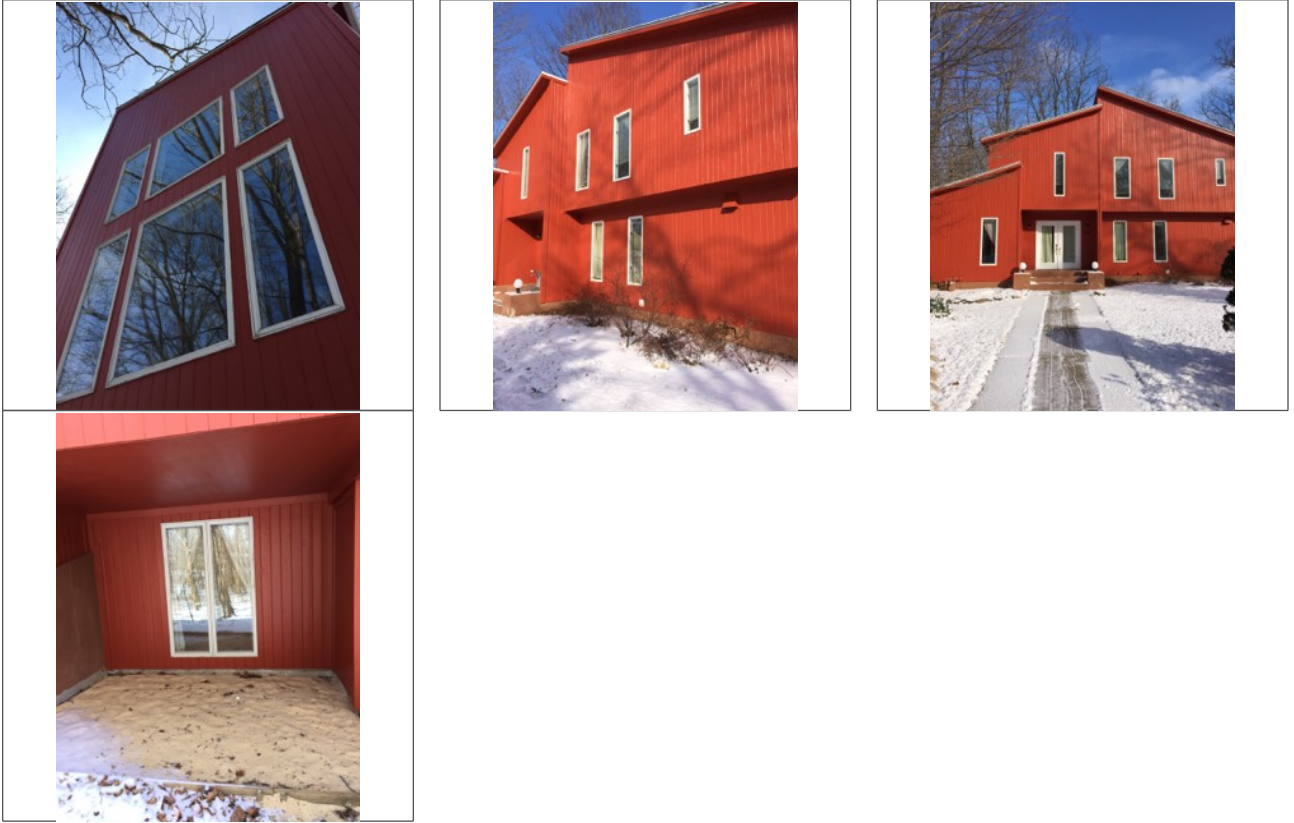
**Condition** ☒ Satisfactory ☐ Marginal ☐ Poor ☐ Wood rot ☐ Recommend repair/painting  
☐ Recommend repair/replace damaged screens ☐ Failed/fogged insulated glass  
**Material** ☐ Wood ☐ Metal ☒ Vinyl ☐ Aluminum/Vinyl clad  
**Screens** ☐ Torn ☐ Bent ☒ Not installed ☐ Satisfactory  
**Comments** Casement windows storm windows not needed.

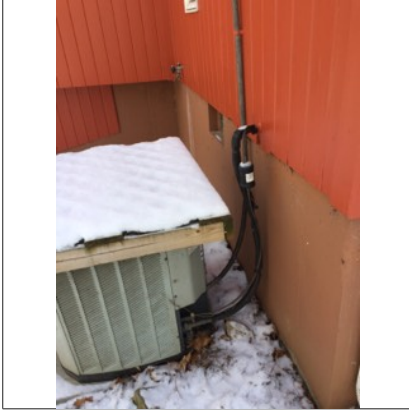
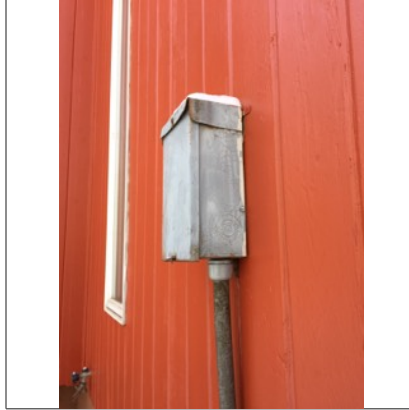
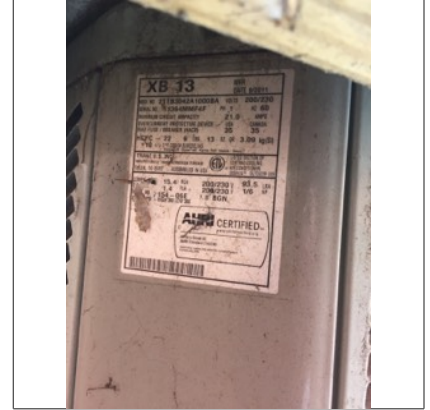
**Comments** Unable to open disconnect box couldn't check breaker.

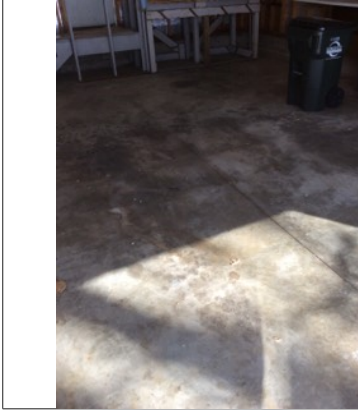
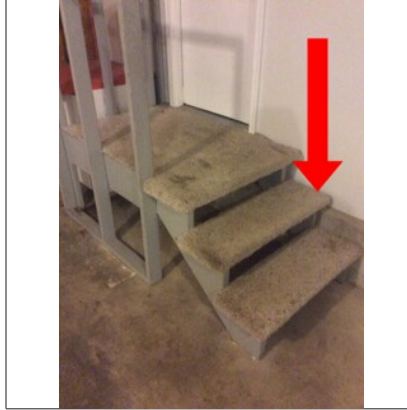
**Comments** Steps leading into garage have loose treads, recommend repair, trip hazard.

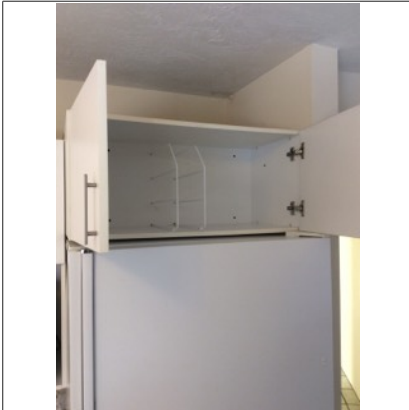
**Condition** ☒ Satisfactory ☐ Marginal ☒ Recommend repair/adjustment

**Comments** Cabinet above fridge in need of readjustment recommend repair. Recommend tightening hinge on cabinet door under sink.

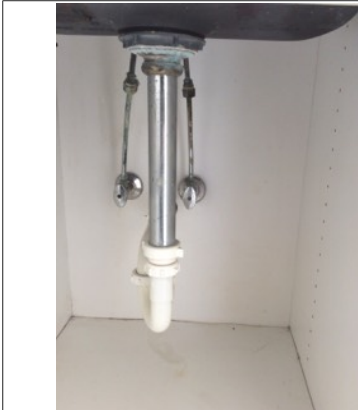
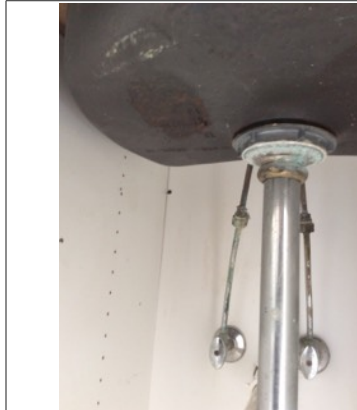
**Comments** Some corrosion at hot/cold water hook ups for washer and under sink due to dissimilar metals, recommend monitor/repair.  
 Open ground within 6 feet of water. Recommend repair

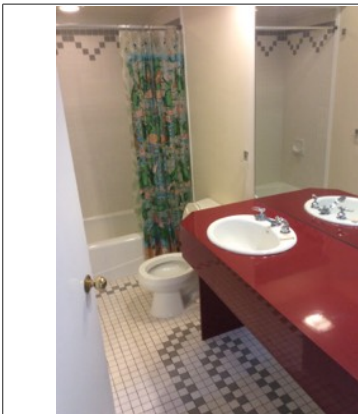
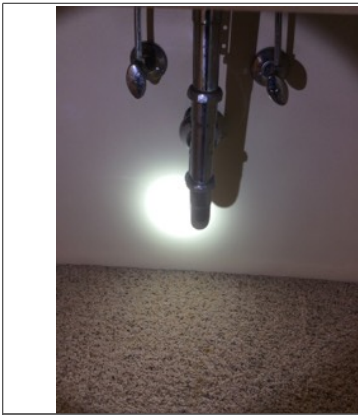
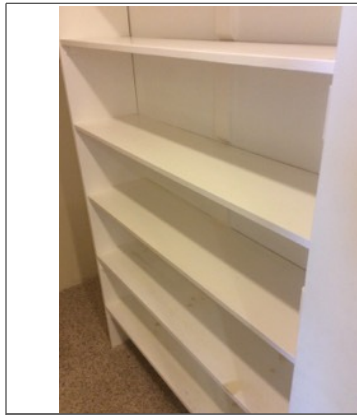
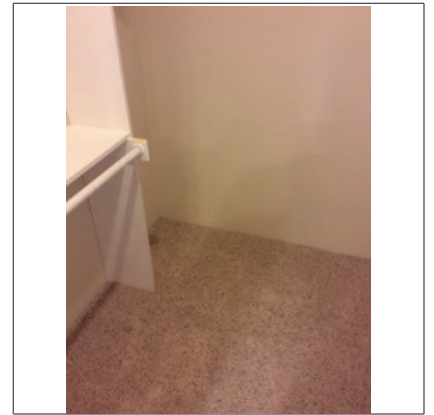
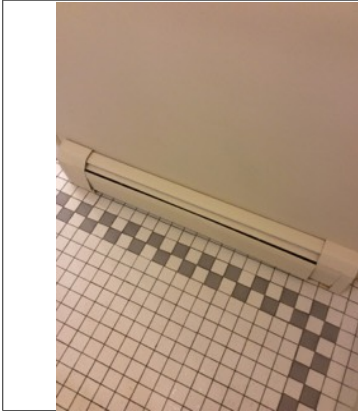
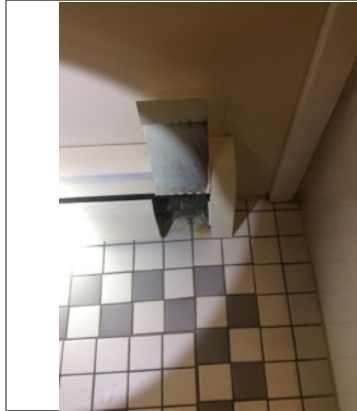
Moisture stains present under sink where carpet is and under the connection to the baseboard heating unit, recommend monitor.

Places where moisture staining present due to dissimilar metals recommend monitor/repair as necessary.

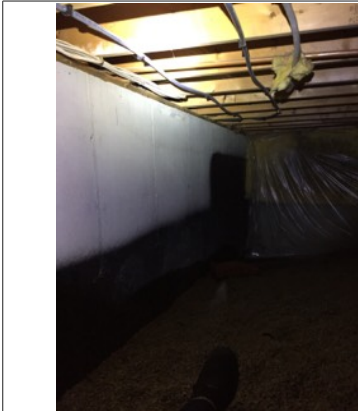
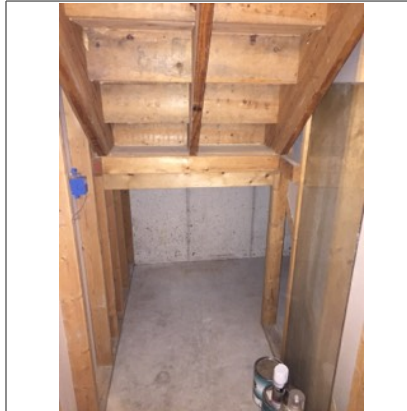
**Condition** ☒ Satisfactory ☐ Marginal ☐ Have Evaluated ☐ Monitor ☒ Cracks ☐ Movement  
**Material** ☐ Concrete block ☒ Poured concrete ☐ Stone ☐ ICF ☐ Wood ☐ Brick  
**Comments** Typical cracks.  
**Photos**

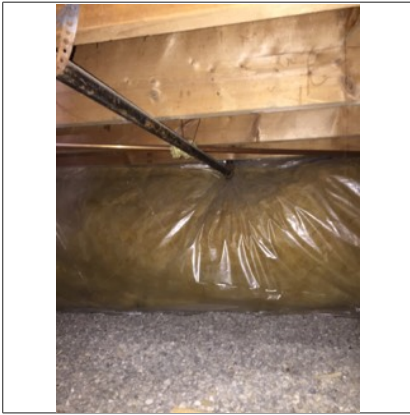
### Floor

**Material** ☐ Concrete ☒ Gravel ☐ Dirt Other: .  
**Condition** ☐ Typical cracks ☐ Not Visible ☒ Vapor barrier present  
**Comments** Floor appeared to be in overall satisfactory condition.  
**Photos**

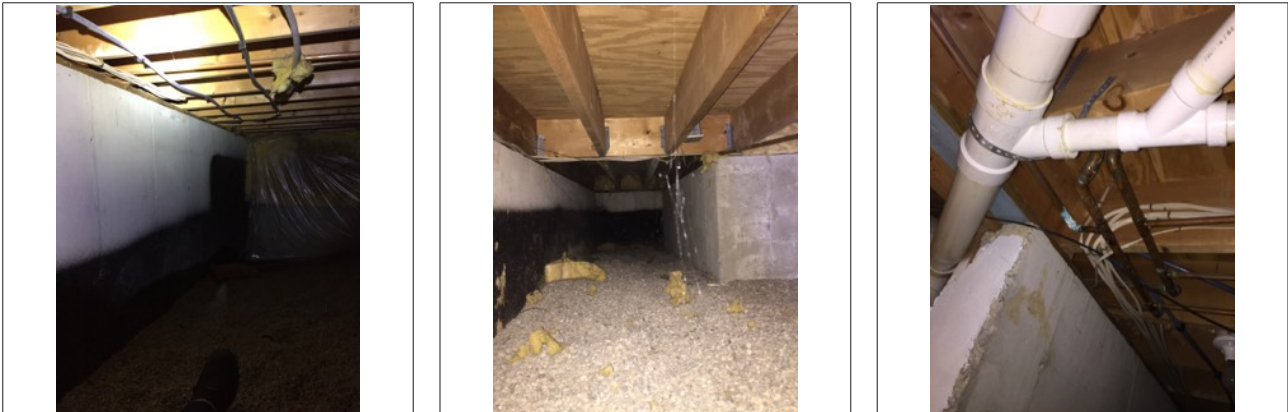
Girders/Beams/Columns

Material    ☐ Steel    ☒ Wood    ☐ Masonry  
Condition    ☒ Satisfactory    ☐ Marginal    ☐ Poor    ☐ Not Visible    ☐ Sagging/Altered  
Comments  
Photos

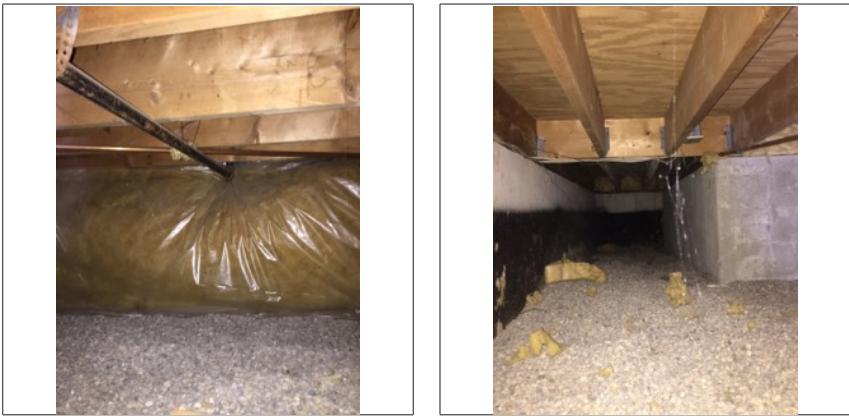
Joists

Material    ☒ Wood    ☐ Steel    ☐ Truss    ☐ Not Visible    ☐ 2x8    ☒ 2x10    ☐ 2x12    ☐ Engineered I-Type  
                  ☐ Sagging/Altered joists  
Comments  
Condition    ☒ Satisfactory    ☐ Marginal    ☐ Poor

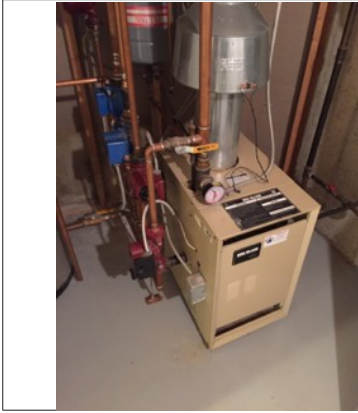
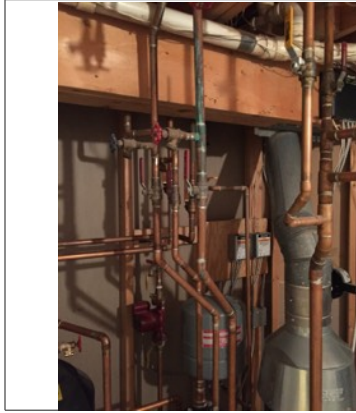
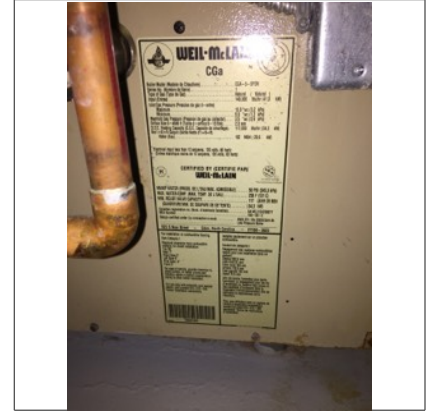
## Boiler system

**Comments** Boiler was in normal working order at the time of the inspection.

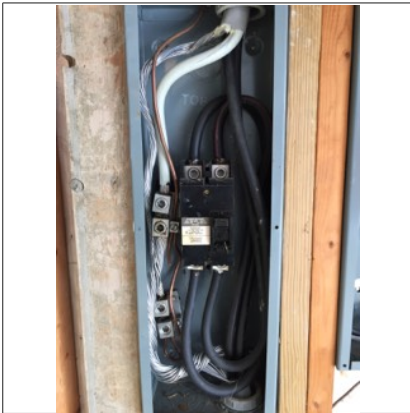
**Location** Garage  
**Condition** ☒ Satisfactory ☐ Poor  
**Amperage/Voltage** ☐ Unknown ☐ 60a ☐ 100a ☐ 150a ☒ 200a ☐ 400a ☐ 120v/240v  
**Adequate Clearance to Panel** ☒ Yes ☐ No  
**Breakers/Fuses** ☒ Breakers ☐ Fuses  
**Appears grounded** ☒ Yes ☐ No ☐ Not Visible  
**GFCI breaker** ☒ Yes ☐ No Operable: ☒ Yes ☐ No  
**AFCI breaker** ☒ Yes ☐ No Operable: ☒ Yes ☐ No ☐ Not Tested  
**Main wire** ☐ Copper ☒ Aluminum ☐ Not Visible ☐ Double tapping of the main wire  
 Condition: ☒ Satisfactory ☐ Marginal ☐ Poor  
**Branch wire** ☒ Copper ☐ Aluminum ☐ Solid Branch Aluminum Wiring ☐ Not Visible ☐ Safety Hazard  
**Branch wire condition** ☒ Satisfactory ☐ Poor ☐ Recommend electrician evaluate/repair ☒ Romex ☐ BX cable  
☒ Conduit ☐ Knob/Tube ☐ Double tapping ☐ Wires undersized/oversized breaker/fuse  
☐ Panel not accessible ☐ Not evaluated  
 Reason:

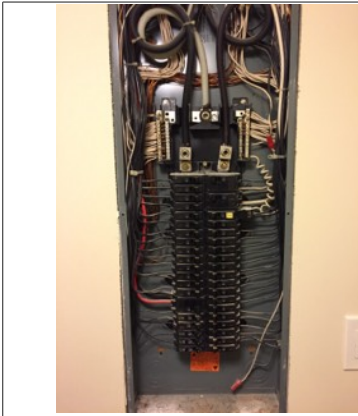
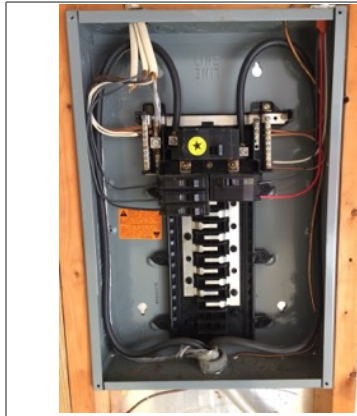
## Sub panel(s)

☐ None apparent  
**Location(s)** Location 1:  
 Basement  
 Location 2:  
 Garage  
 Location 3:  
**Evaluation** ☐ Panel not accessible ☐ Not evaluated  
 Reason:  
☐ Recommend separating/isolating neutrals ☐ Recommend electrician repair/evaluate box  
**Branch wire** ☒ Copper ☐ Aluminum ☐ Safety hazard Neutral/ground separated: ☒ Yes ☐ No  
 Neutral isolated: ☒ Yes ☐ No  
**Condition** ☒ Satisfactory ☐ Marginal ☐ Poor  
**Comments** No signs of overheating were evident at the time of the inspection.  
 Outlets were randomly tested and had correct polarity, except as noted.

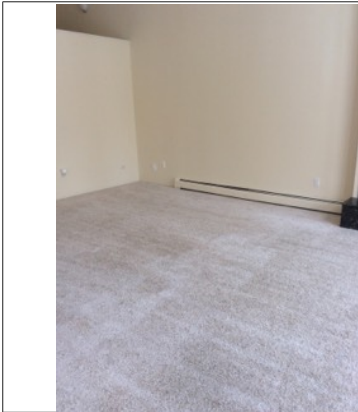
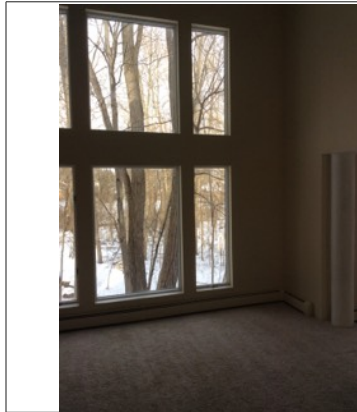
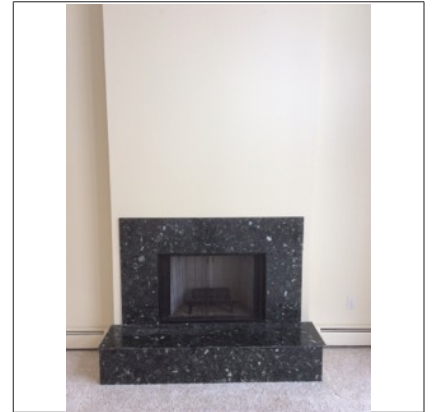
**Comments** Outlet to the left of fireplace is on the switch next to thermostat.
